Manhole Inspection Summary

Manhole # S31G__032MH

Insp Date: **8/11/08 8:46 AM**

Location Address: **10 n green st**

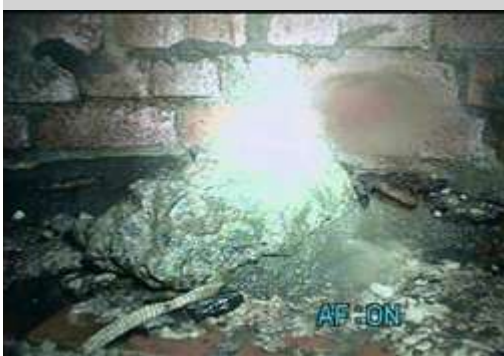
bench debris

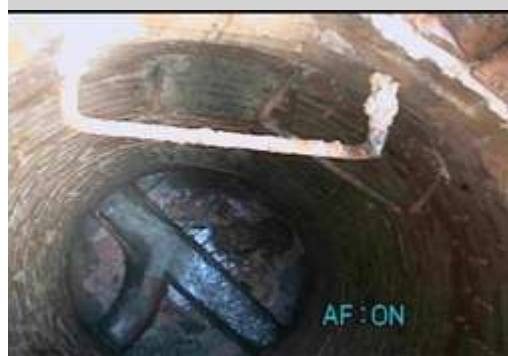
Defect 2

Count: **6** Missing: **0** ☒ **Corroded**

steps

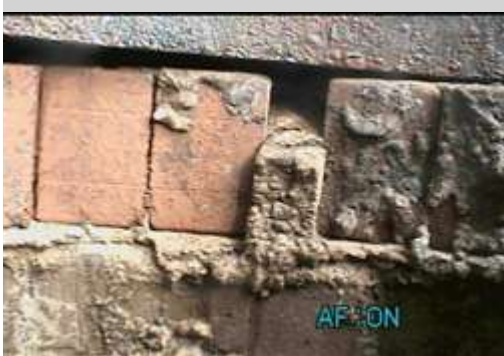
Defect 1

Condition: ☐ Sound ☒ **Cracked** ☐ Root Intrusion ☒ **Loose Brick** ☐ Deteriorated

loose bricks, cracked, frame adj

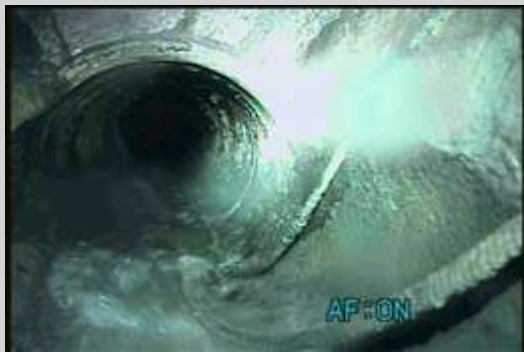
12 O'Clock Outflow

8 in. Circular Gravity Sewer
Pipe Out @ 12 O'Clock

Invert Depth: 11.41 (ft.) Flow Characteristics: **Fast**

Deposits: ☒ None ☐ Mud ☐ Sludge ☐ Debris ☐ Grease

Infiltration: **None** Pipe Seal Cond: **Unknown**

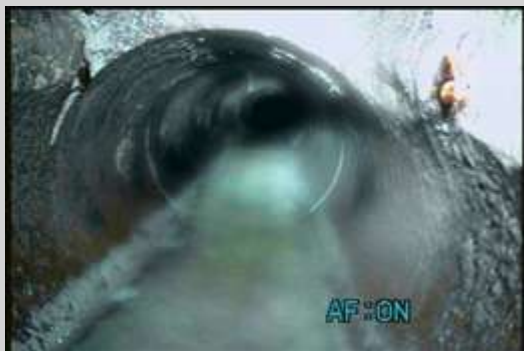
6 O'Clock Inflow

10 in. Circular Gravity Sewer
Pipe In @ 6 O'Clock

Invert Depth: 11.33 (ft.) Flow Characteristics: **Fast**

Deposits: ☒ None ☐ Mud ☐ Sludge ☐ Debris ☐ Grease

Infiltration: **None** Pipe Seal Cond: **Unknown**

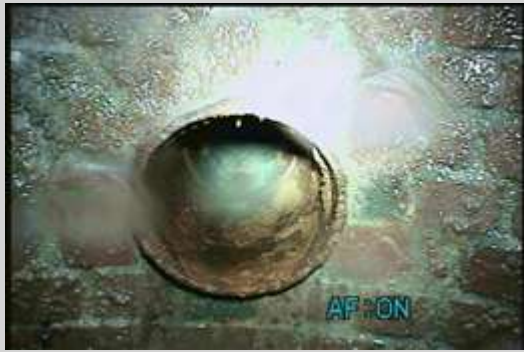
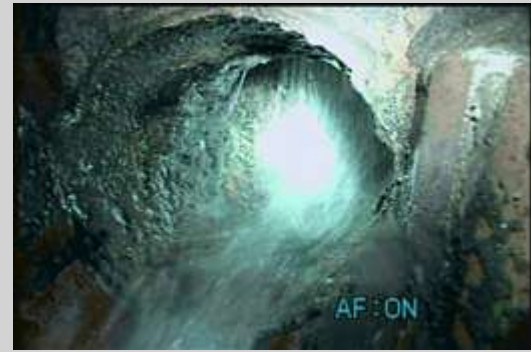
9 O'Clock Inflow

8 in. Circular Gravity Sewer

Pipe In @ 9 O'Clock

Drop In @ 9 O'Clock

Drop: Outside Direct

Drop Condition: Open
